# Christmas Music in the Chamber

How a sprinkler system brought radio noise to a chamber and the techniques used to find and remove it

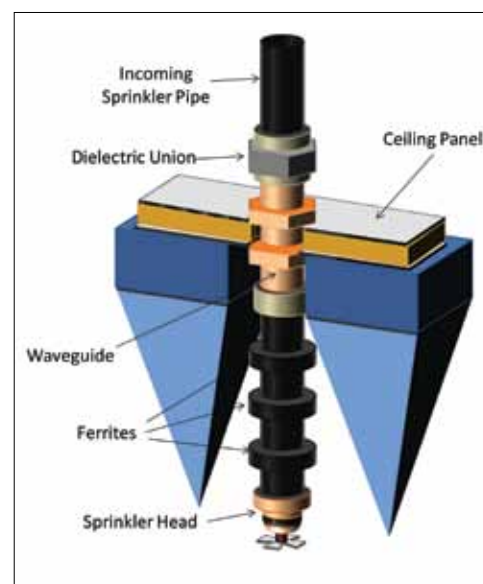
**Figure 1.** Construction of sprinkler at anechoic chamber ceiling.

Finally we had to resort to using the biconical antenna with the amplifier connected to the EMI receiver inside the room. A biconical antenna is usually useful between 20 and 300MHz, designed to pick up the FM radio stations that were plaguing it. Leaving the antenna on the tripod in the vertical orientation and locating it at various spots in the room it became very evident that the signal was coming mostly in through the center sprinkler head which was located directly above the normal test location of the antenna. Every sprinkler head had three very large ferrite rings. We tried moving all the ferrites on the center sprinkler head to one spot on the pipe and the noise became stronger. The two other sprinklers on the sides of the center sprinkler head had weaker FM signals. We wiggled the center sprinkler increasing the conductivity and the FM Christmas music disappeared. We were enthusiastic; it looked like there was a problem with a connection on the top of the chamber that we could easily solve by improving the electrical contact. The many components of a typical chamber sprinkler feed are shown in Figure 1. The brass waveguide provides the necessary electrical grounding of the sprinkler pipe to the chamber, allows for water flow to the sprinkler head, and blocks noise from coming through the hole that must be cut to allow passage of the pipe into the room. If the waveguide is not electrically contacting the chamber walls, then the sprinkler pipe can conduct radio stations into the room.

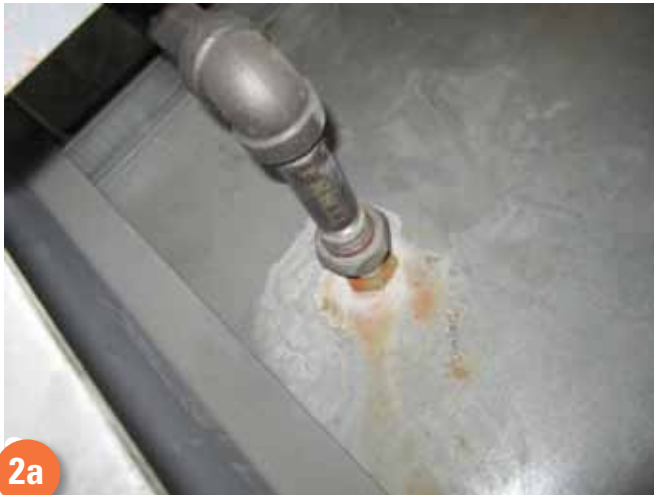
2a

**Figure 2.** Condition of sprinkler condition at top of chamber. (a) Corrosion at one of the waveguides on top of the chamber. (b) The same waveguide after cleaning. Brass wool can be seen between the waveguide nut and the chamber surface.

Up on top of the chamber it was easy to see the root cause of the problem. Chamber sprinklers are a disaster waiting to happen. The fire marshal requires that the system must be tested every year. During the testing sometimes the pipe connections may leak. This can spell catastrophe for an ALSE if the water leaks. This sprinkler system had leaked at some time in the past. The leakage was on the chamber roof at a connection to one of waveguides or its associated dielectric union but no one had known it. The water pooled all the way over to the center sprinkler and corroded the metal on the chamber ceiling panel beneath the brass nut that tightens the waveguide to the panel. Imagine what kind of monetary loss would have been involved if a larger leak had occurred and the panel joints became corroded. It is a good practice to periodically inspect the top of the

By loosening the nuts on the two affected waveguides on top of the chamber it was possible to clean out the corrosion using a wire brush. It took more than one attempt to get them clean. After the roof was cleaned and the nuts re-tightened, the signals were checked again. The FM radio noise in the chamber was worse than before. We requested bronze wool to establish a better electrical connection. Placing the wool between the nut and the chamber roof panel was the solution. One of the cleaned and repaired waveguides is shown in Figure 2(b). Corrosion was also present at one of the ceiling panel joints. Since we could not take the joint apart to clean underneath it, we decided to clean the panel next to the joint and place conductive tape to form a bridge between the joint and the panel as shown in Figure 3(b). The Christmas radio signal we saw on the EMI receiver disappeared! A new trace run on the chamber (see Figure 4) confirmed the absence of the Christmas radio noise and reinstated the chamber engineers' Christmas spirit.

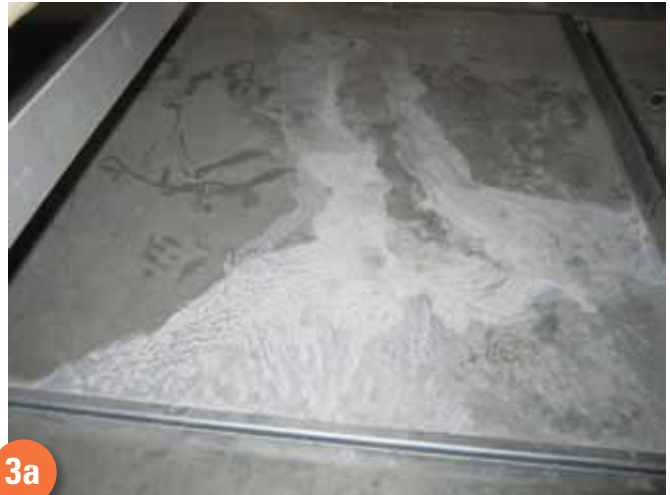
3a

**Figure 3.** Condition of panel joint at top of chamber. (a) Corrosion on the top of the chamber due to pooled water. The corrosion extends to one of the panel joints. (b) Copper tape was used to bridge between the joint and the chamber panel after corrosion was cleaned away. Corrosion under the joint could not be cleaned.

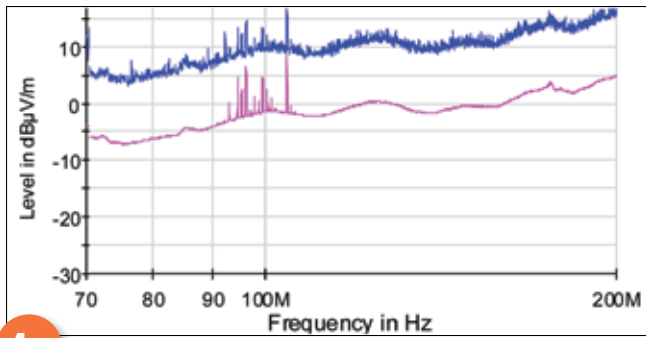
4a

**Figure 4.** Ambient Measurements. (a) Ambient measurement in the FM band before the sprinklers were fixed (blue is Peak and pink is Average detection); (b) Ambient measurement in the FM band after sprinklers were fixed.
